Report Nr.  
17865 - I/2007

Investigation of dehumidifying plaster **aero-durit® EP 2010** regarding the qualification

- as system for application on highly imbued masonry with salt contamination, or
- as measure to permanently dehumidify and dry up masonry

tested under „worst case scenario“ conditions and in comparison with available commercial products.

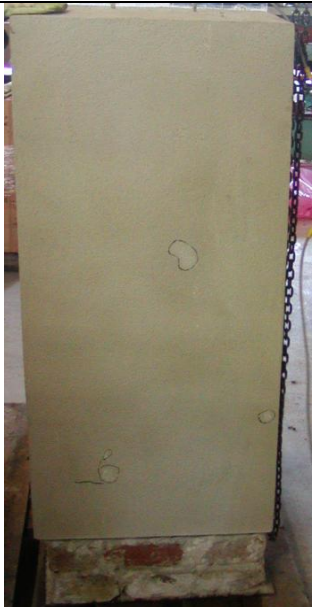
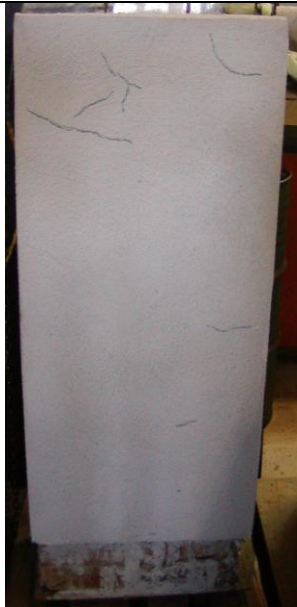
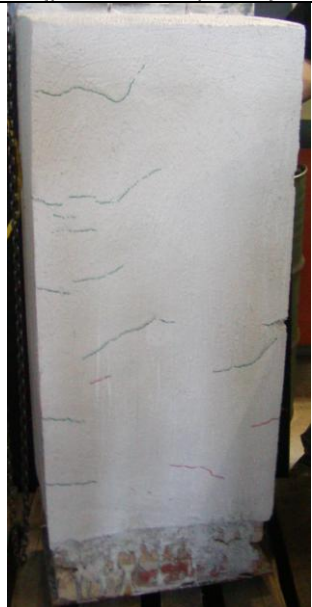
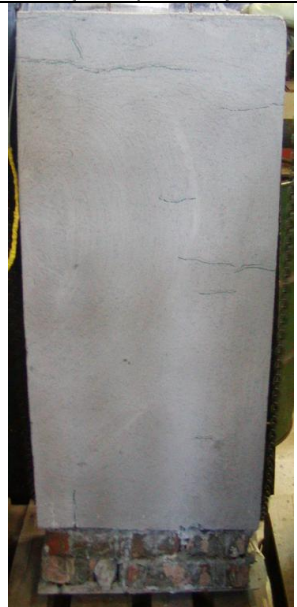
Flaws and cracks that appeared during the period of drying have been recorded by means of photographs.

Column 1 with aero-durit® EP 2010 appeared to remain almost without cracks, whereas the other products clearly displayed cracks.

When applied on masonry with high moisture, aero-durit® EP 2010 was the only product with finally no cracks and flaws.

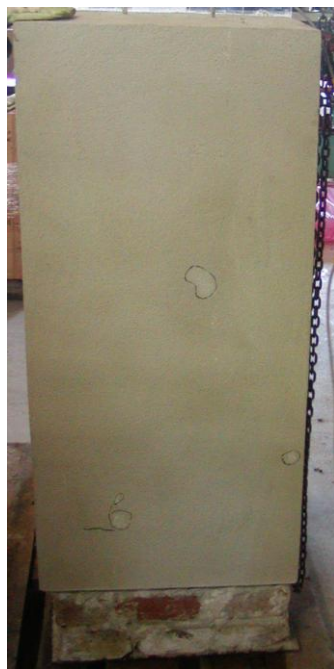
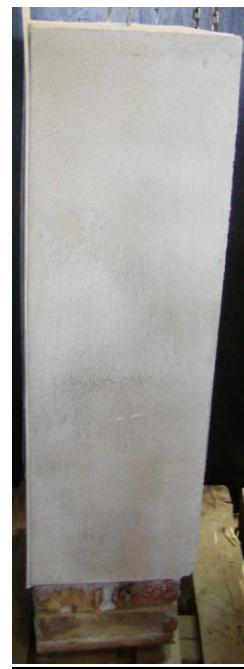
aero-durit® EP 2010 dehumidifying plaster

Aerodurit 2010 EP remained almost without cracks.

As a result of the salt contamination tests, only small local areas showed salt efflorescence. No other significant differences between the 2 columns rendered with aero-durit® EP 2010.

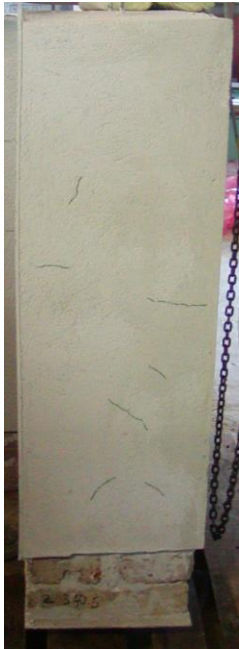
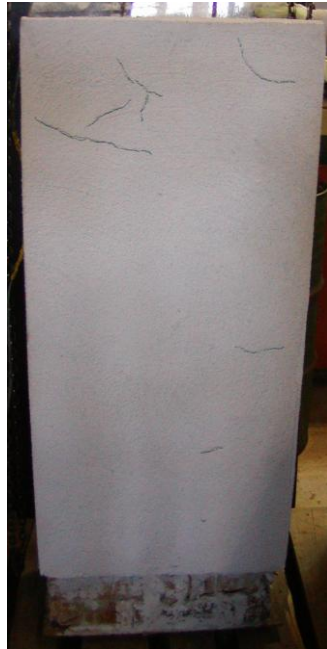
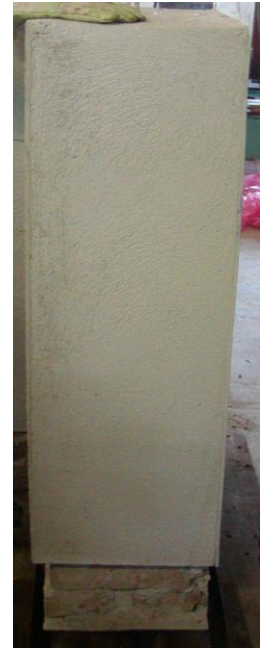
Hand-applied lime cement plaster

Relatively large cracks after dehydration showed on two surfaces.  
Other than the columns with aero-durit® EP 2010, the lower parts of the columns had extensive and uniform areas of salt efflorescence after the salt contamination tests.

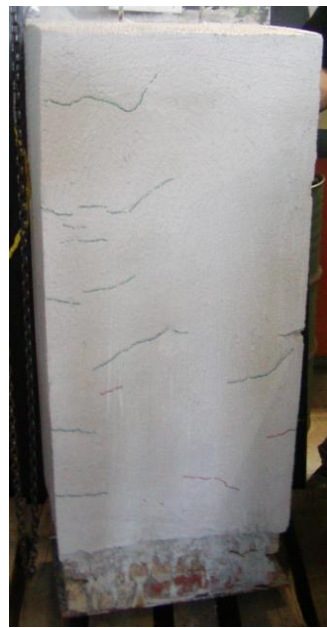
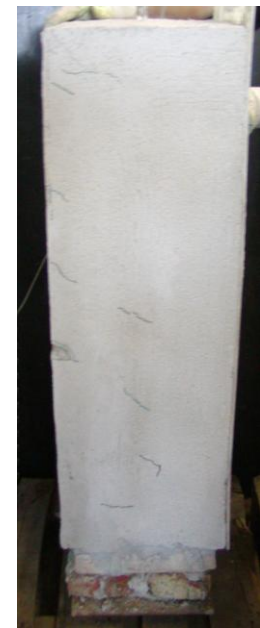
WTA Sanierputz (plaster for plinth)

This plaster showed distinct cracks, especially on the reverse side and on the left side..  
Other than the columns with aero-durit® EP 2010, the lower parts of the columns had extensive and uniform areas of salt efflorescence after the salt contamination tests.

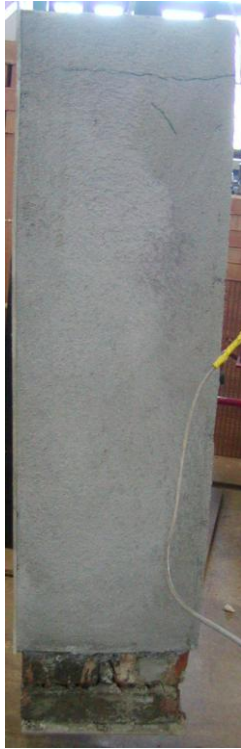
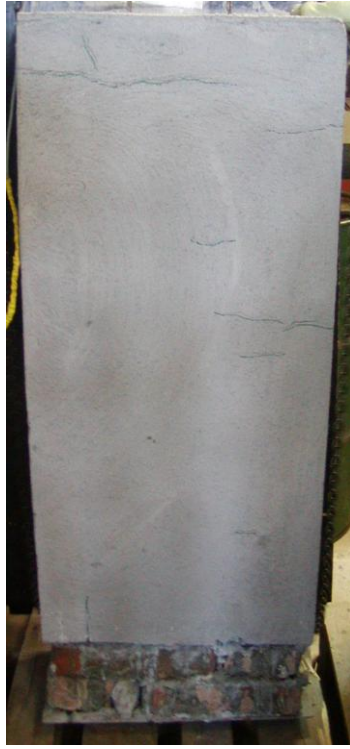
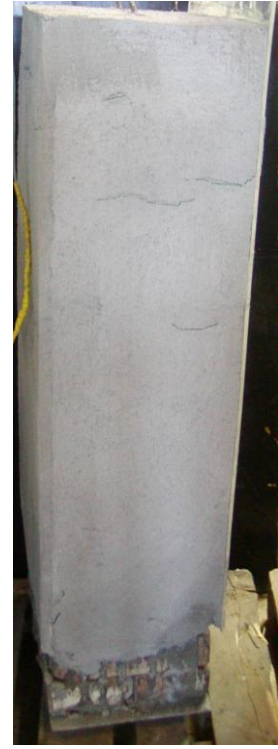
Mikroporenputz (competitor)

This plaster also showed a rather distinct trend to build cracks, but the almost circumferential crack in the upper part (pictures left and in the middle) also might be a result of an application of higher force to the upper part of this column.

[No column rendered with this system was exposed to salt contamination!]

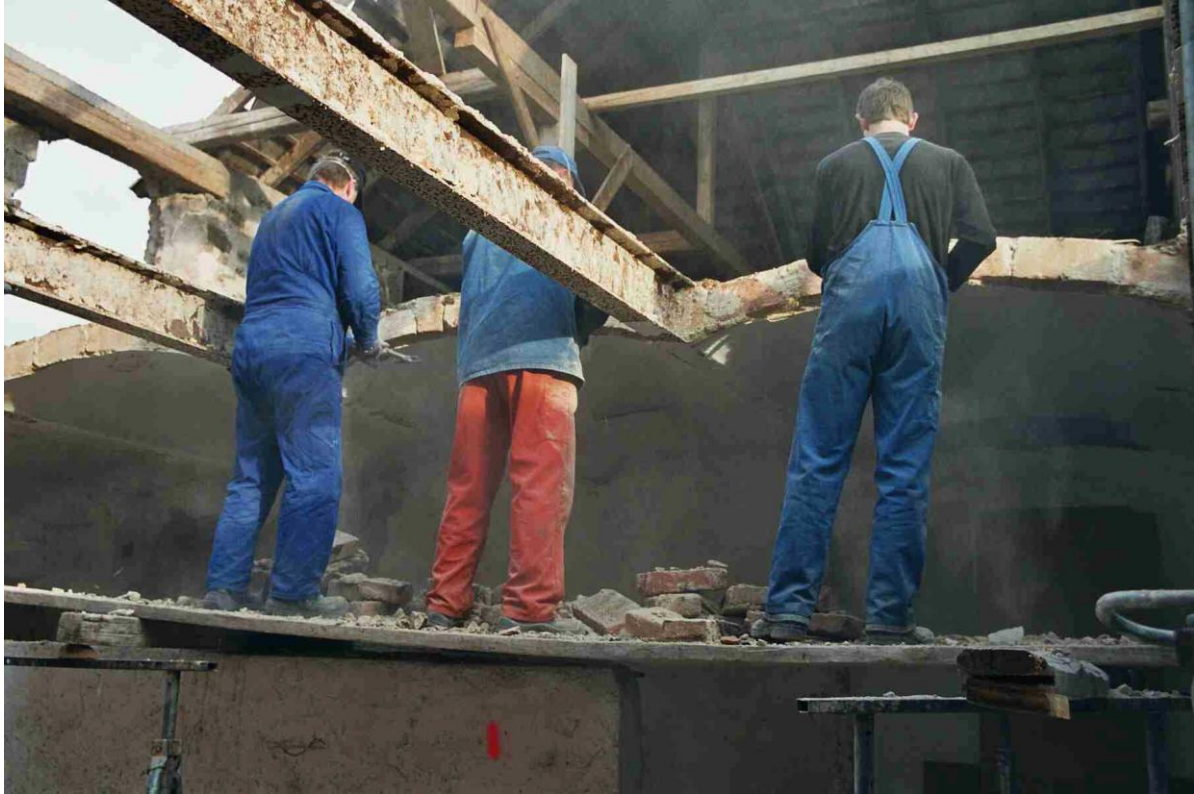
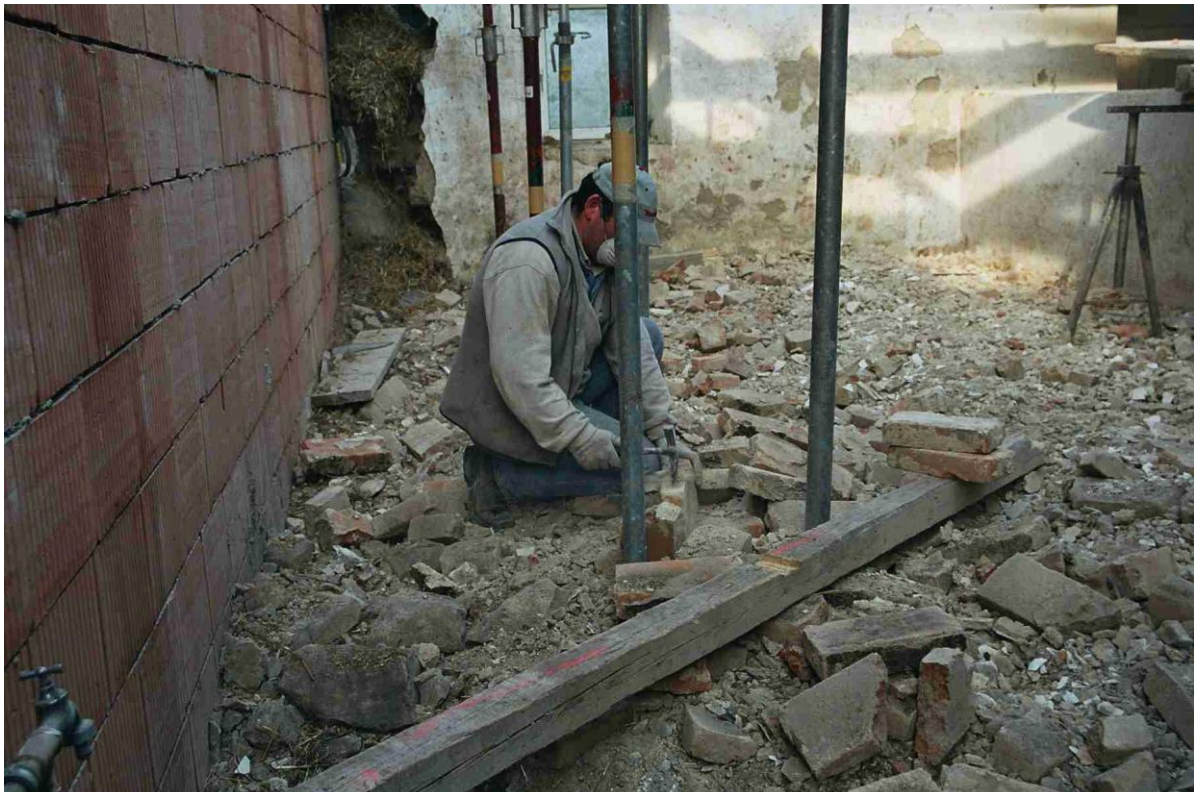
The bricks used for the columns came from a stable of an 100 year old farmhouse and thus have a significant salt contamination.

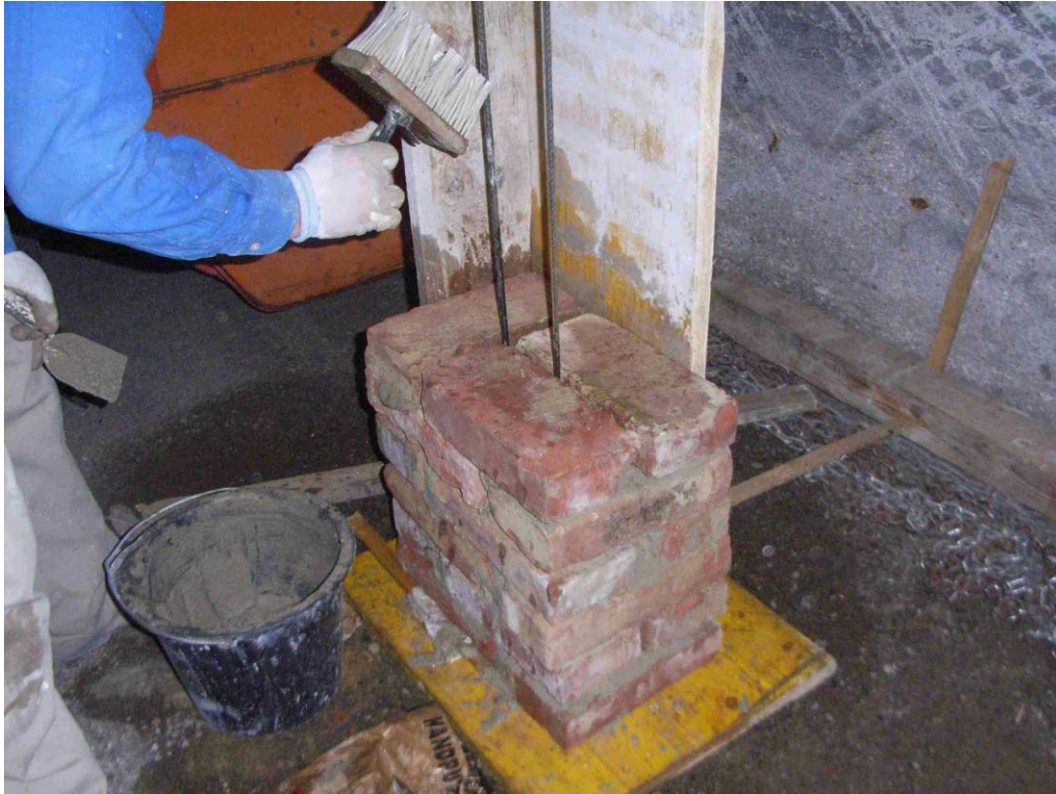
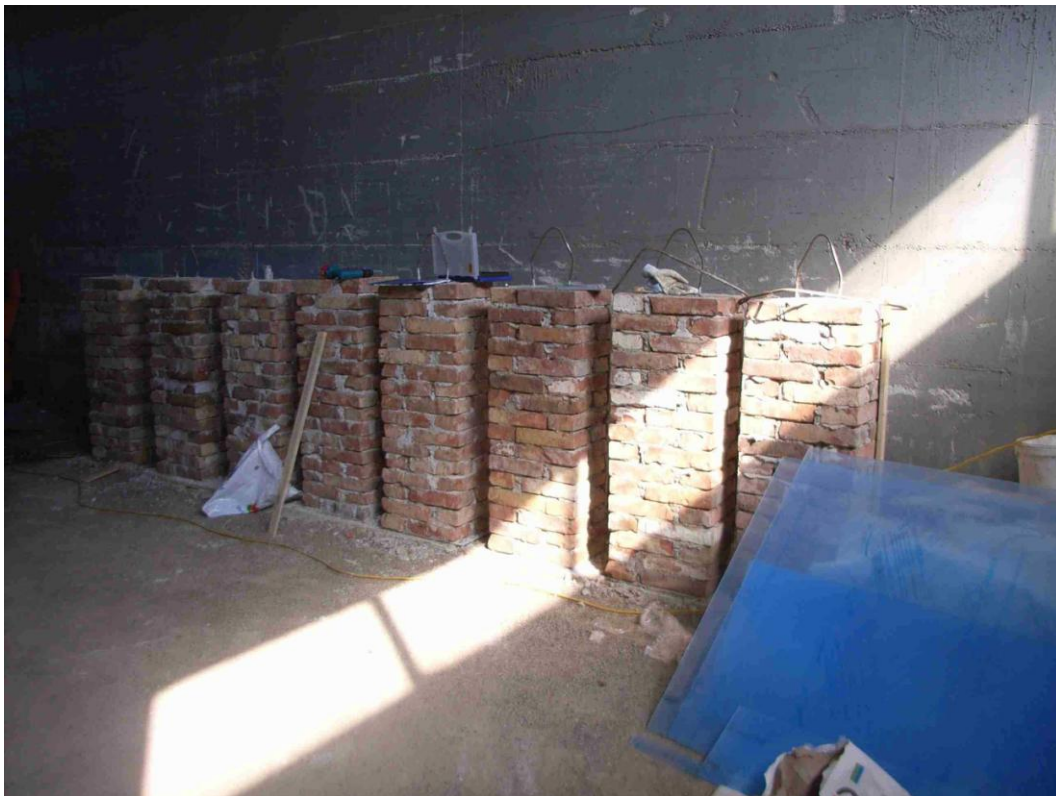
The columns have been built by workers of Firma **rawatecc – Bau und Betontechnologie GmbH**.

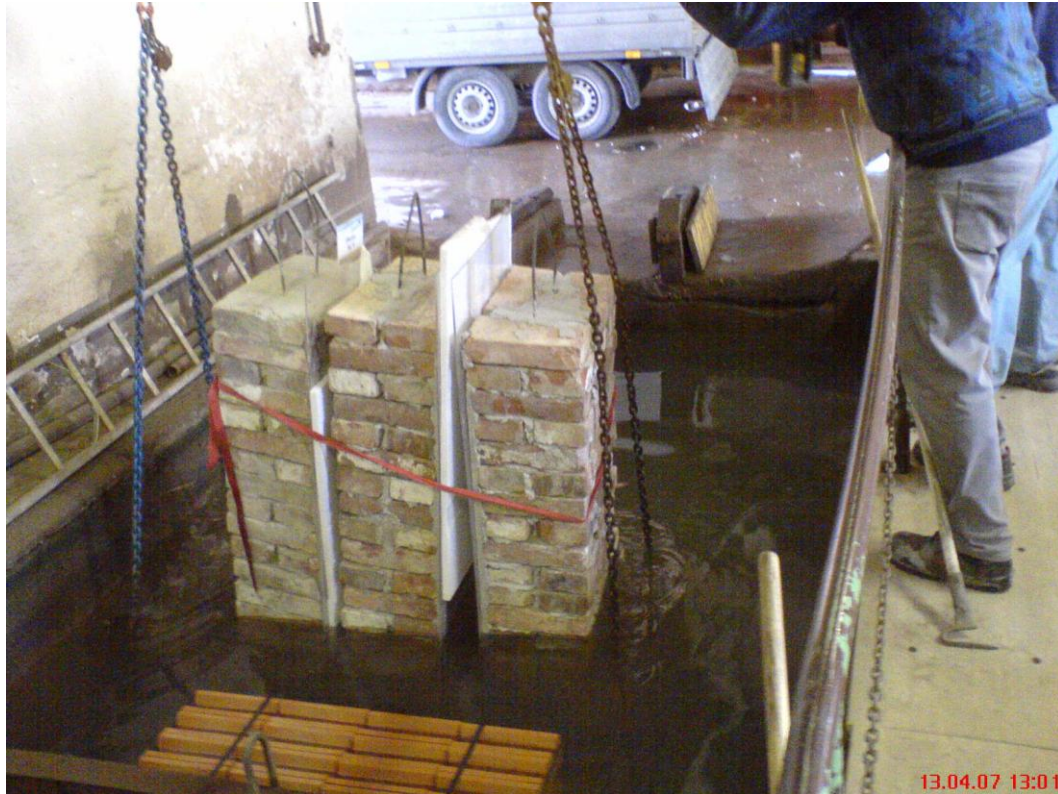
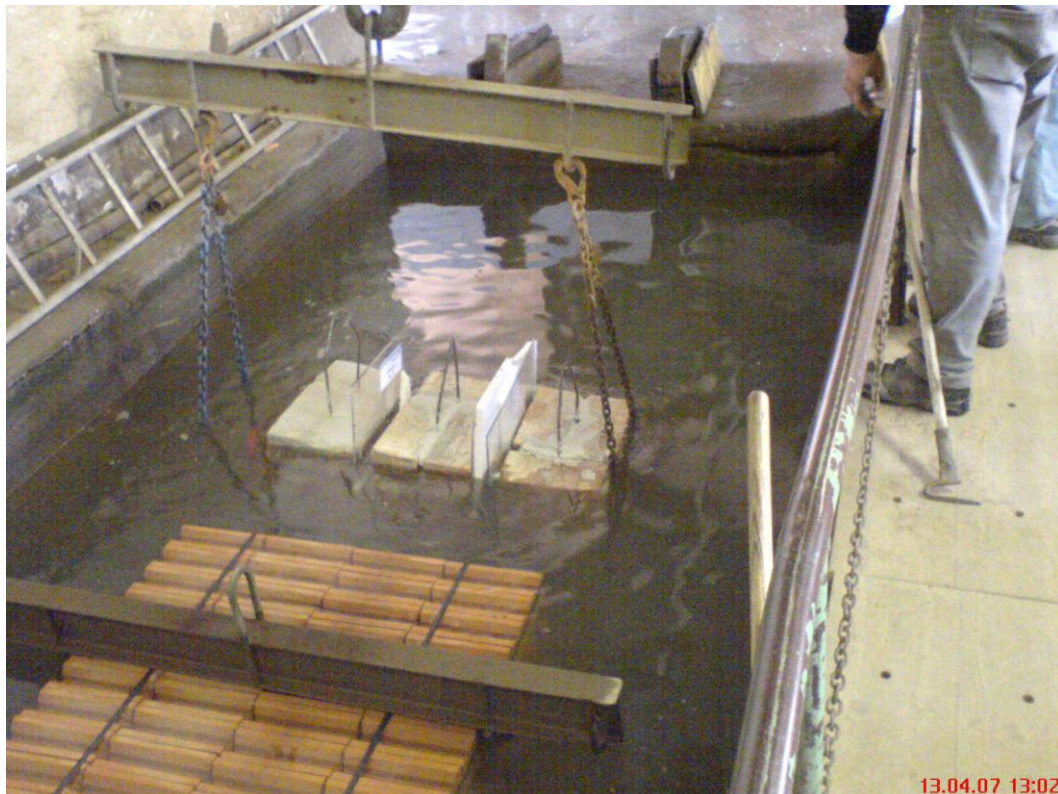
Storing the columns under water preparing „Rendering waterlogged masonry“ to investigate the ability of the mortars to dry up without cracks when applied to masonry with high moisture.

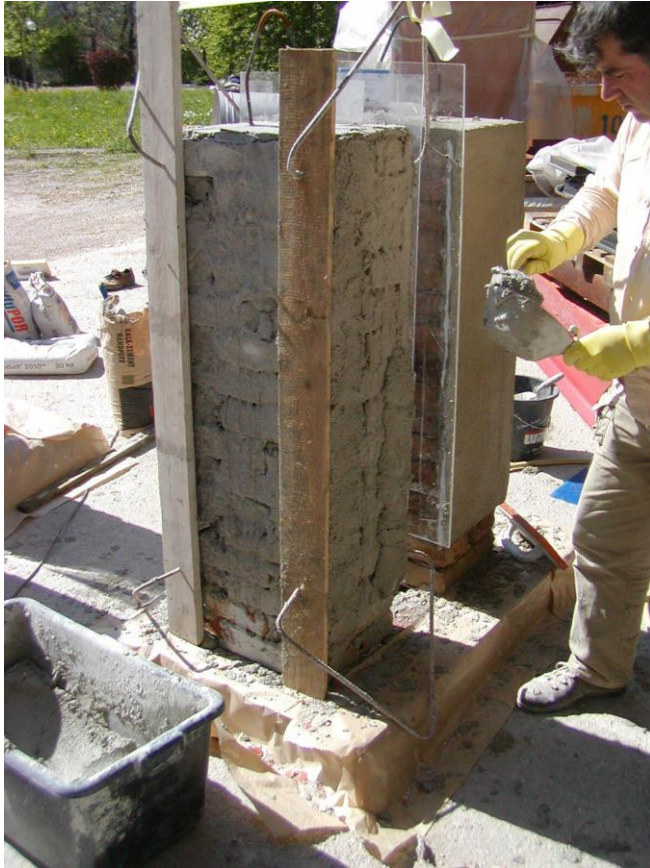
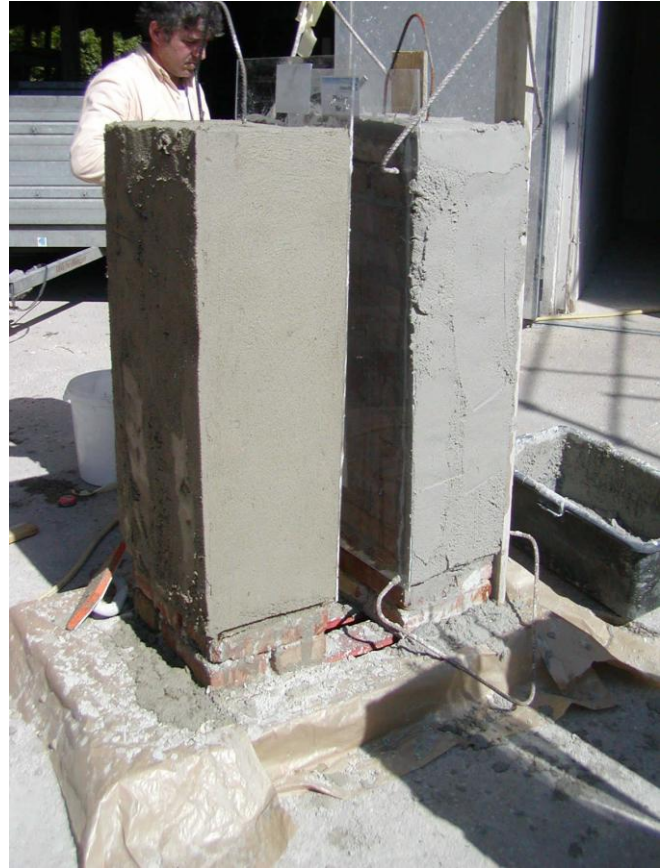
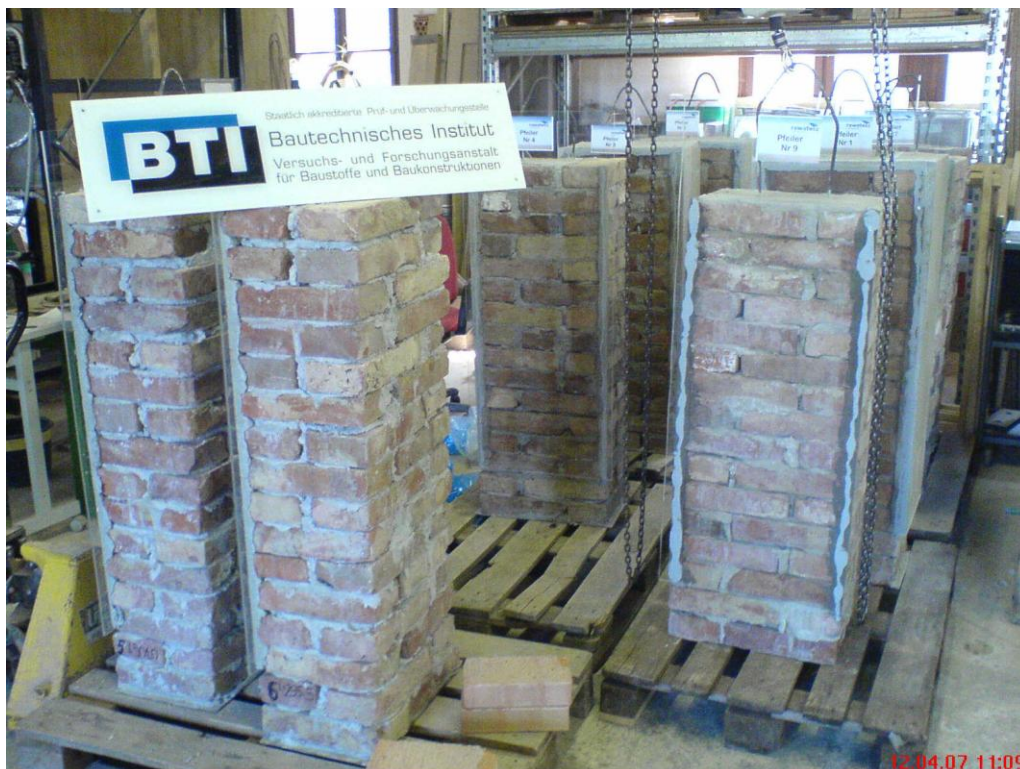
Rendering the columns by workers of Firma rawatecc – Bau und Betontechnologie GmbH.

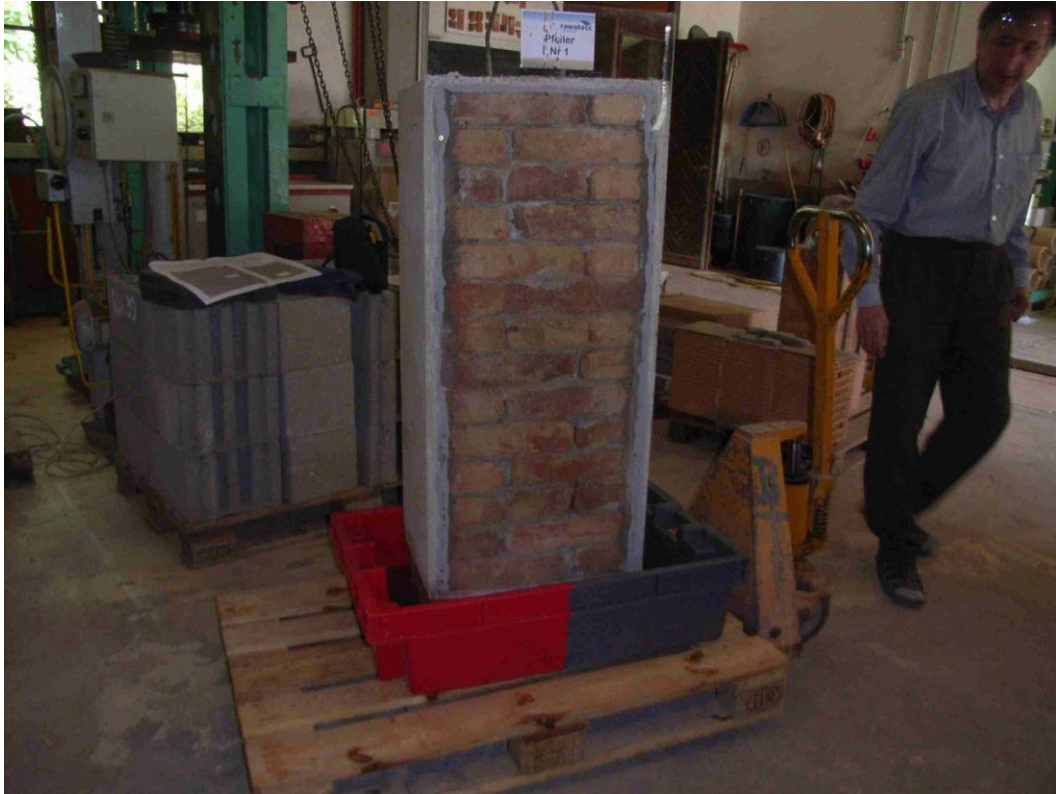
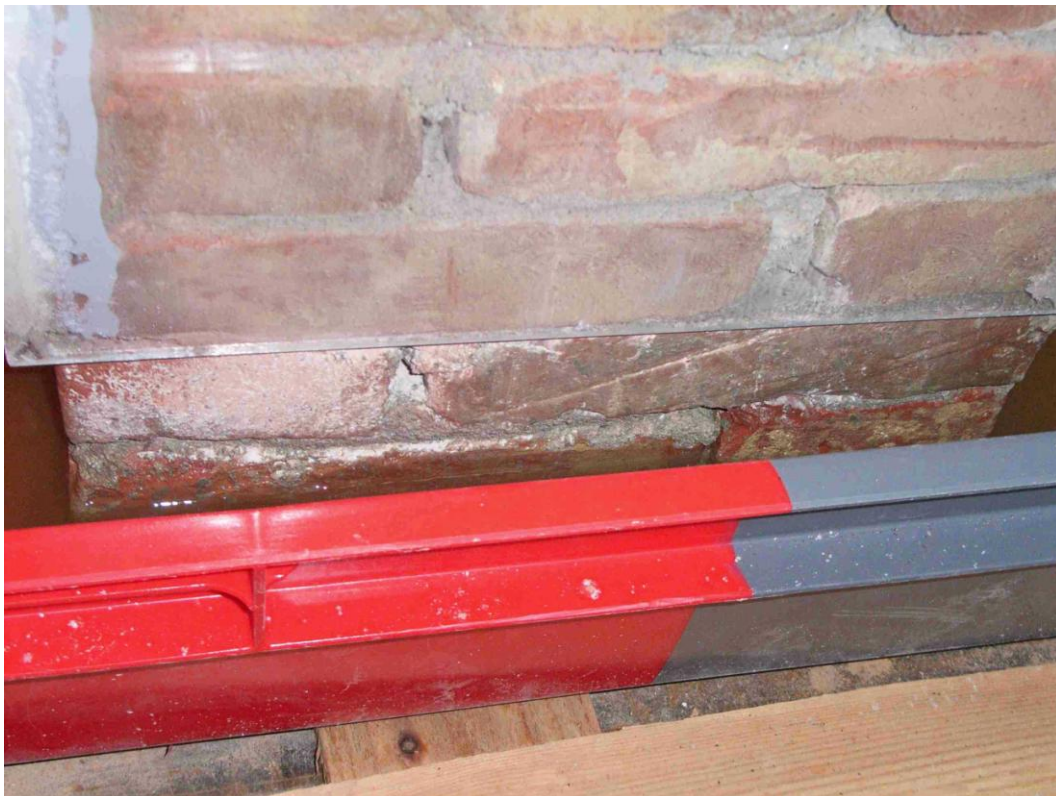
Columns stored in 10 % sodium chloride solution for salt resistance test.
